## Structural Home Inspection Report

TO: Jane Doe  
19402 77<sup>th</sup> St E  
Bonney Lake WA 98391

INSPECTION DATE: February 26, 2010

**Address of Residence Inspected:** 19402 77<sup>th</sup> St E, Bonney Lake WA 98391

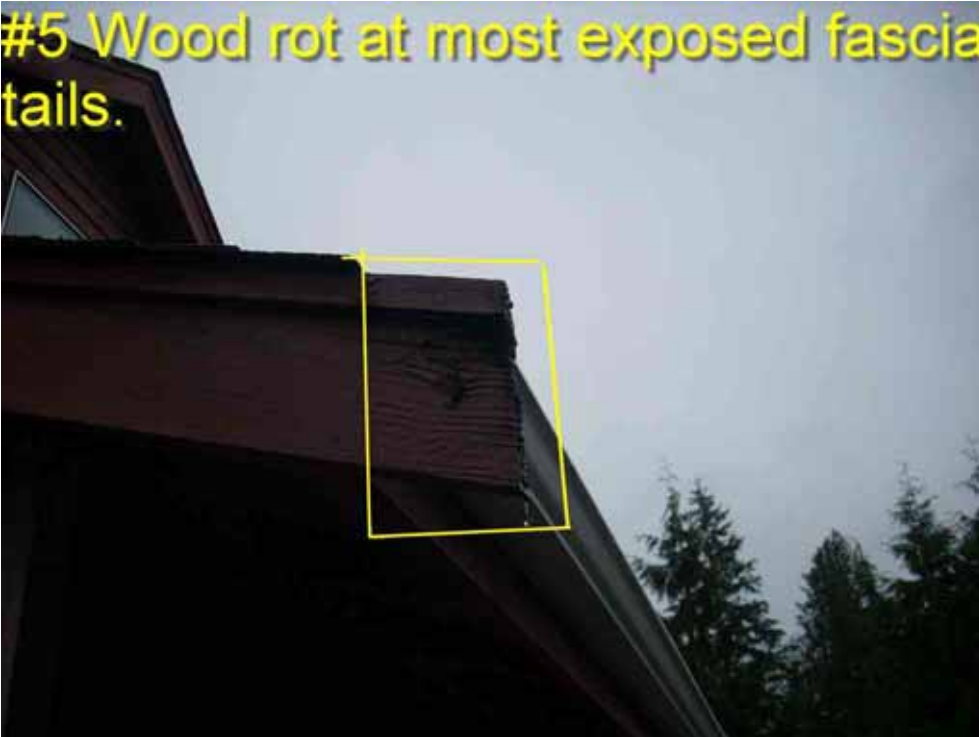
- e. There is wood rot at most of the exposed fascia tails. These should be cut off or replaced. (See Photo#5, 6, 7, 28)
- f. There is wood rot at the garage door jamb at the bottom. This is due to earth to wood contact and southern weather exposure. (See Photo#22, 23)

#5 Wood rot at most exposed fascia tails.

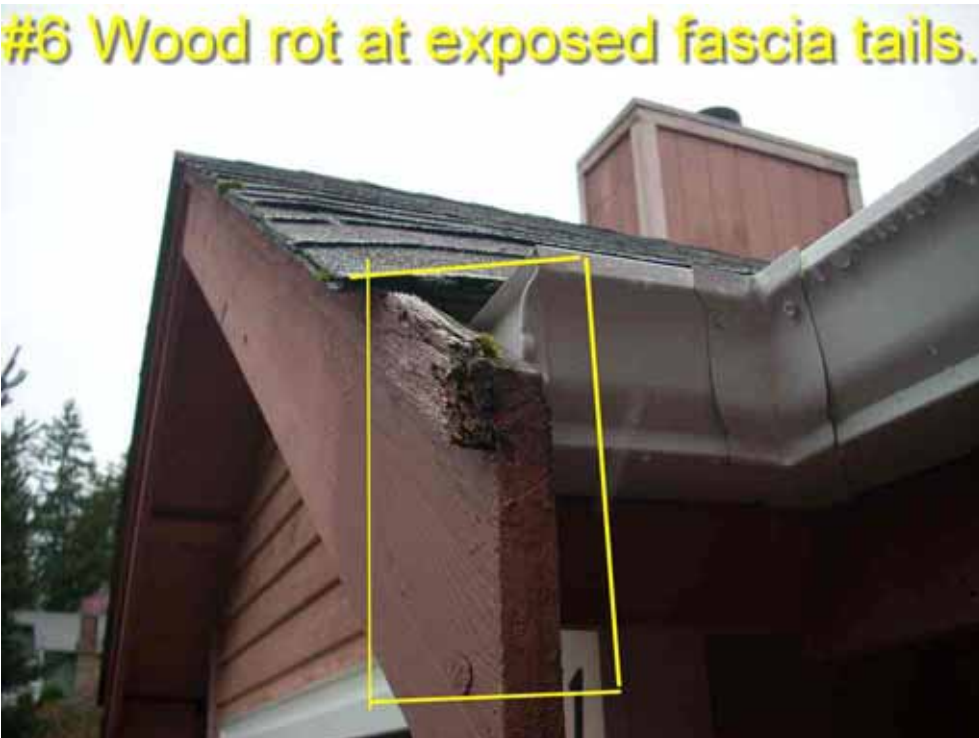
#6 Wood rot at exposed fascia tails.

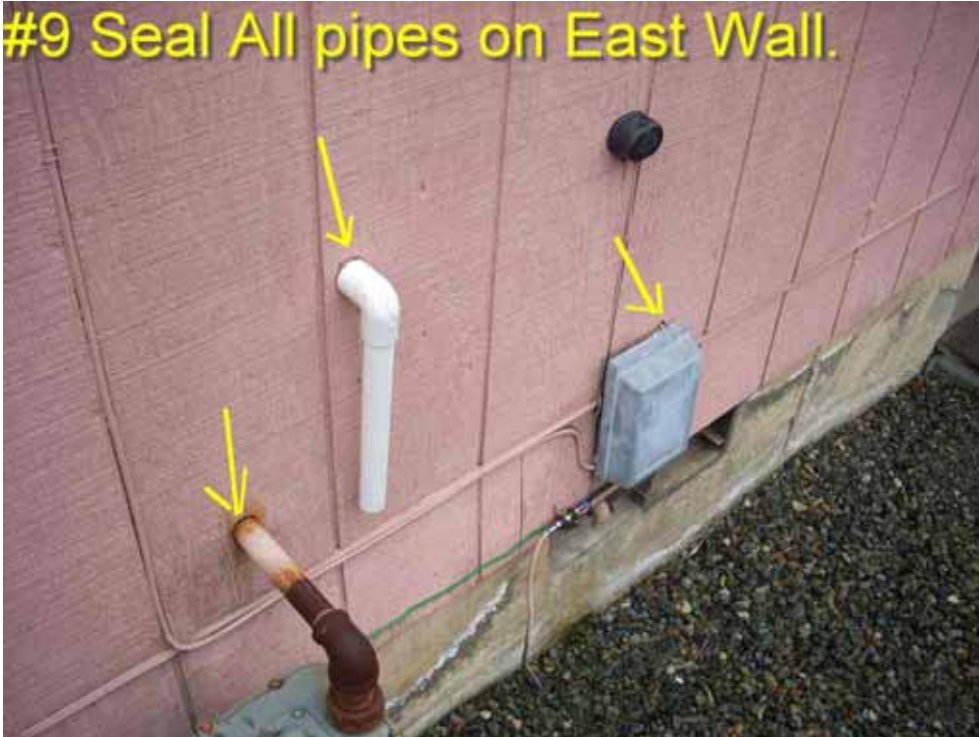
- 1. Seal the pipe and wire entry points on the East side to prevent hidden water damage. Use Quad caulking by OSI for all exterior caulking needs. (See Photo#9)

#9 Seal All pipes on East Wall.

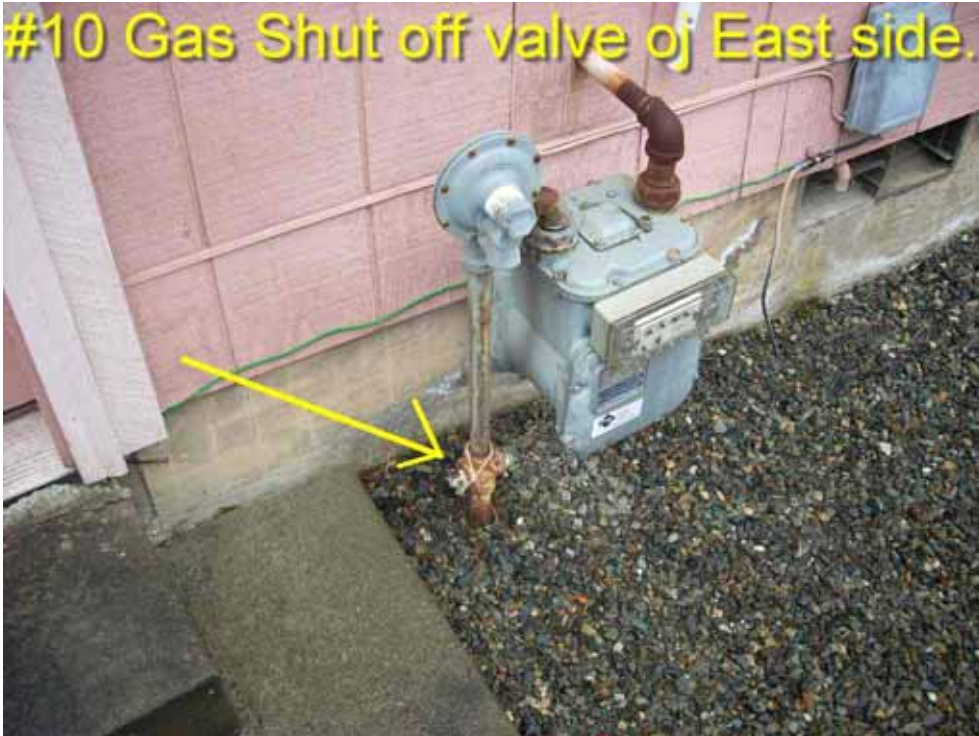
#10 Gas Shut off valve of East side.

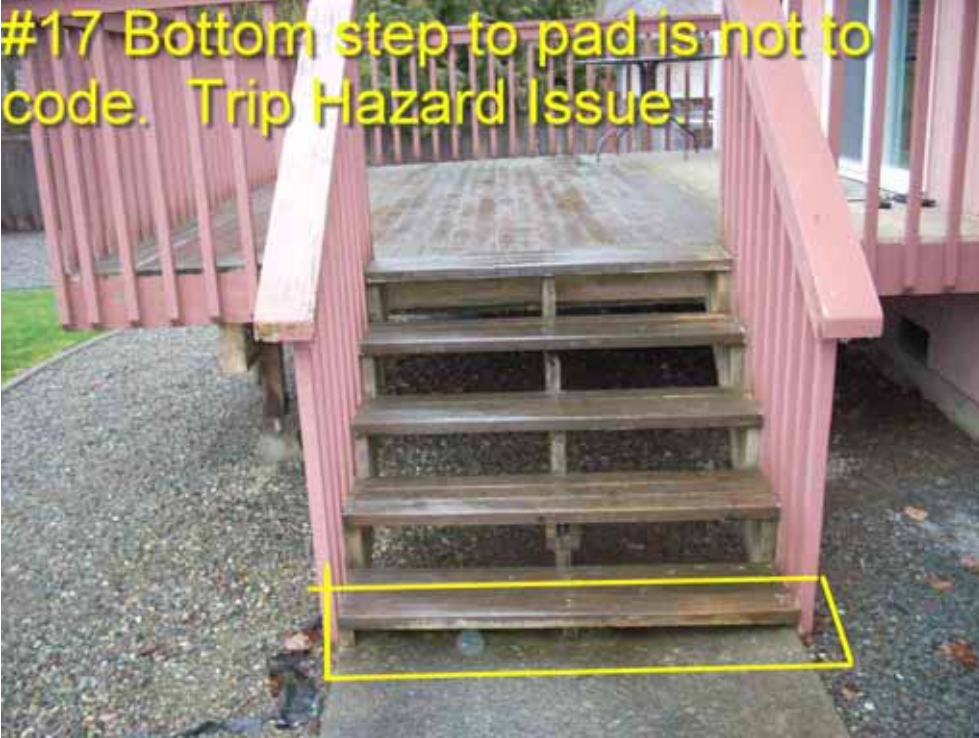
- a. The deck structure is not secured to the wall framing with lag bolts. (See Photo#13)
- b. The deck landing does not meet code requirements, and is a trip hazard since the pad is not equal-distant with the risers. (See Photo#17)
- c. There is a trip hazard at the drive way expansion joint. If re-poured, the slabs should be secured with rebar. (See Photo#24)
- d. The unfinished and exposed wood members in the garage are fire risk. Have these covered with 5/8" Type X dry wall board and fire taped. (This was not a code requirement in 1988, and thus optional, but recommended). (See Photo#47)
- e. The main beam support is missing through bolts at the base bracket. Code Requirement Issue. (See Photo#48)

#17 Bottom step to pad is not to code. Trip Hazard Issue.

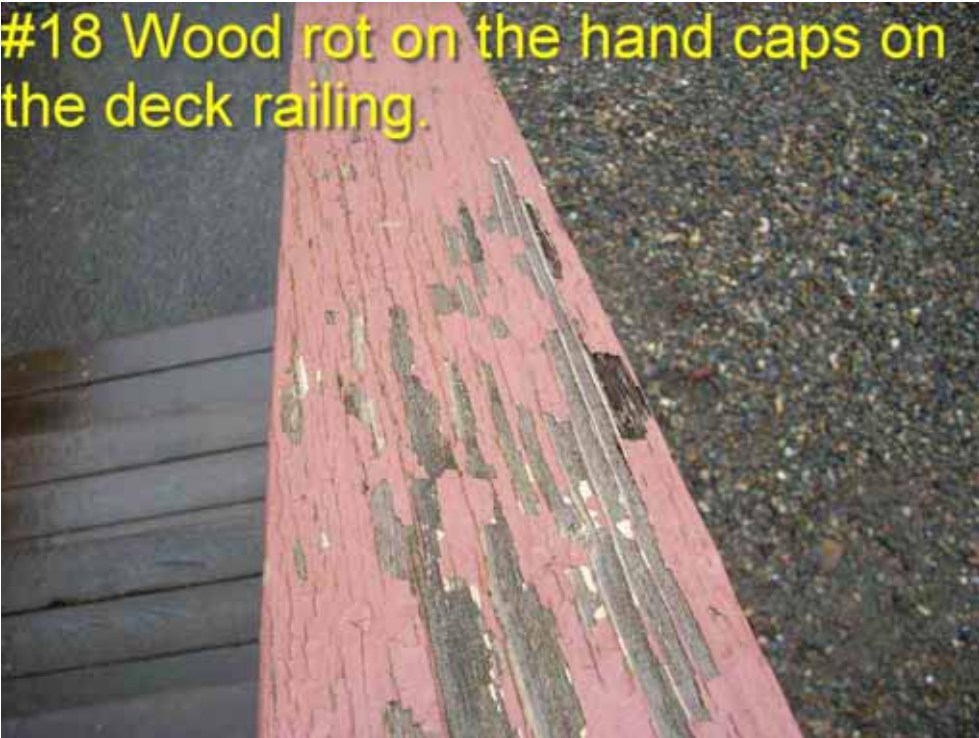
#18 Wood rot on the hand caps on the deck railing.

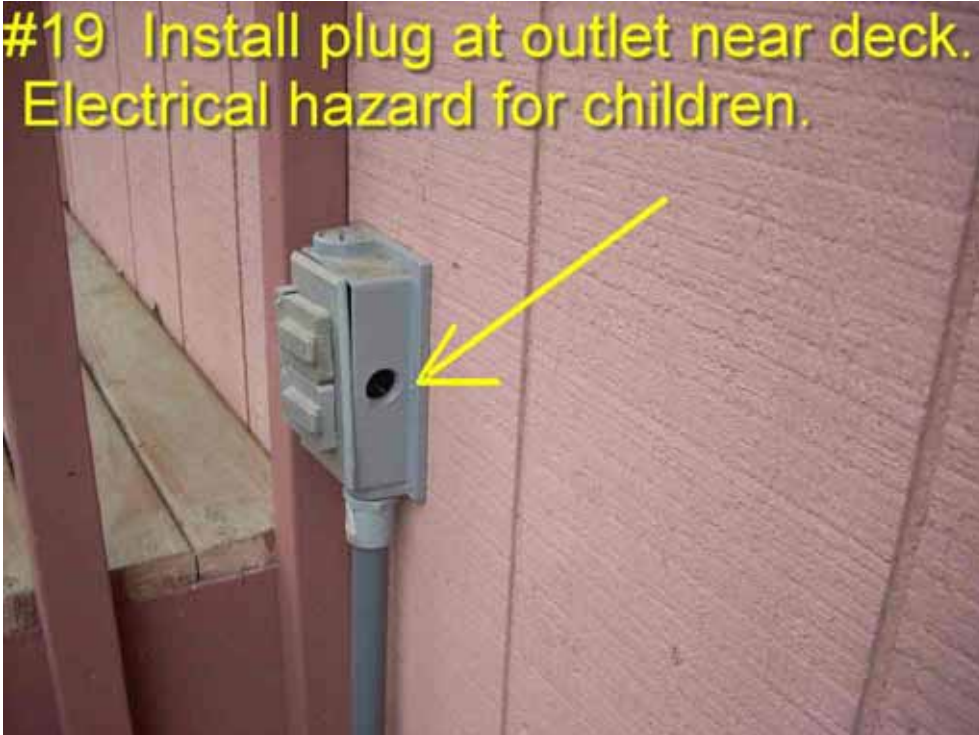
- a. The outside electrical box next to the deck has hole in the side which needs a plug. Safety hazard for children. (See Photo#19)
- b. The range venting wire is not protected in BX cable as required by code. (See Photo#46)
- c. For electrical issues contact Jim Dorrough with Kanon Electric at 253-312-8971.

#19 Install plug at outlet near deck.  
Electrical hazard for children.

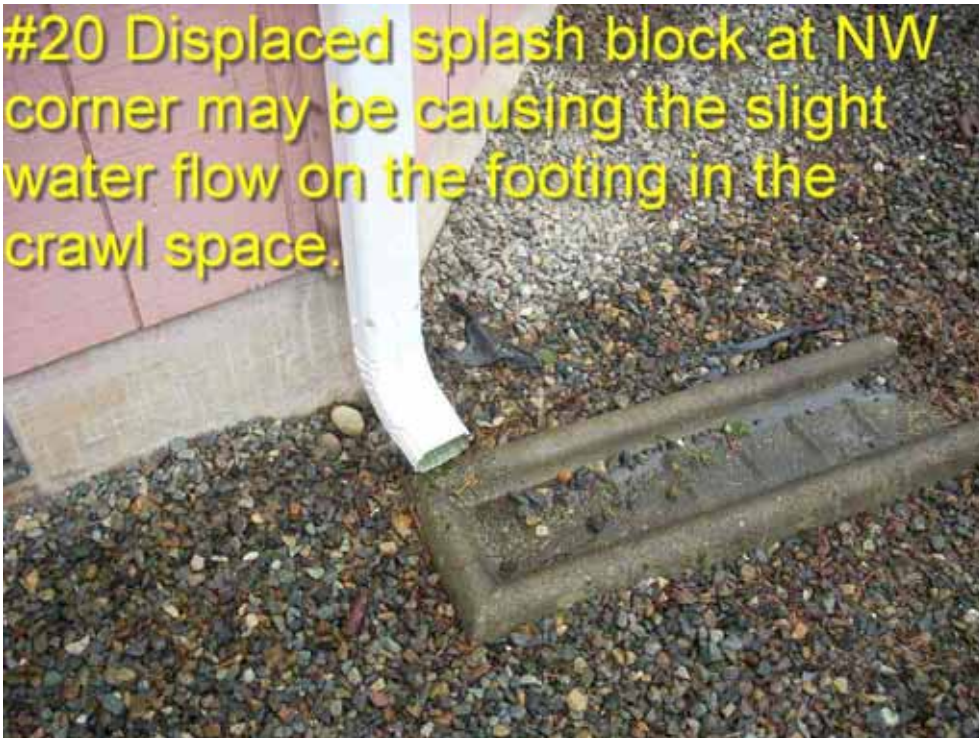
- 2. The displaced splash block on the NW corner appears to contributing to the water leaching over the footing inc the crawl space (See Photo#20, 58)
- 3. There is some light moss on the roof. Have this removed. (See Photo#26)

#20 Displaced splash block at NW  
corner may be causing the slight  
water flow on the footing in the  
crawl space.

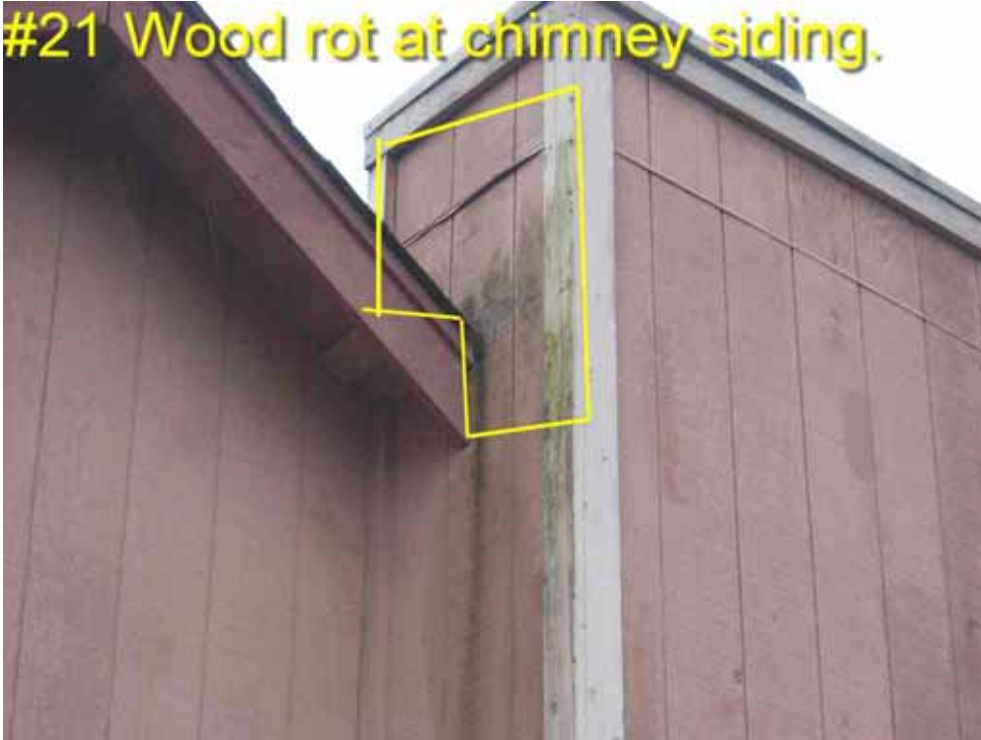
- d. There is wood rot at the chimney tower on the north side. This area should have a cricket installed to prevent this from happening in the future. (See Photo#21, 31)

#21 Wood rot at chimney siding.

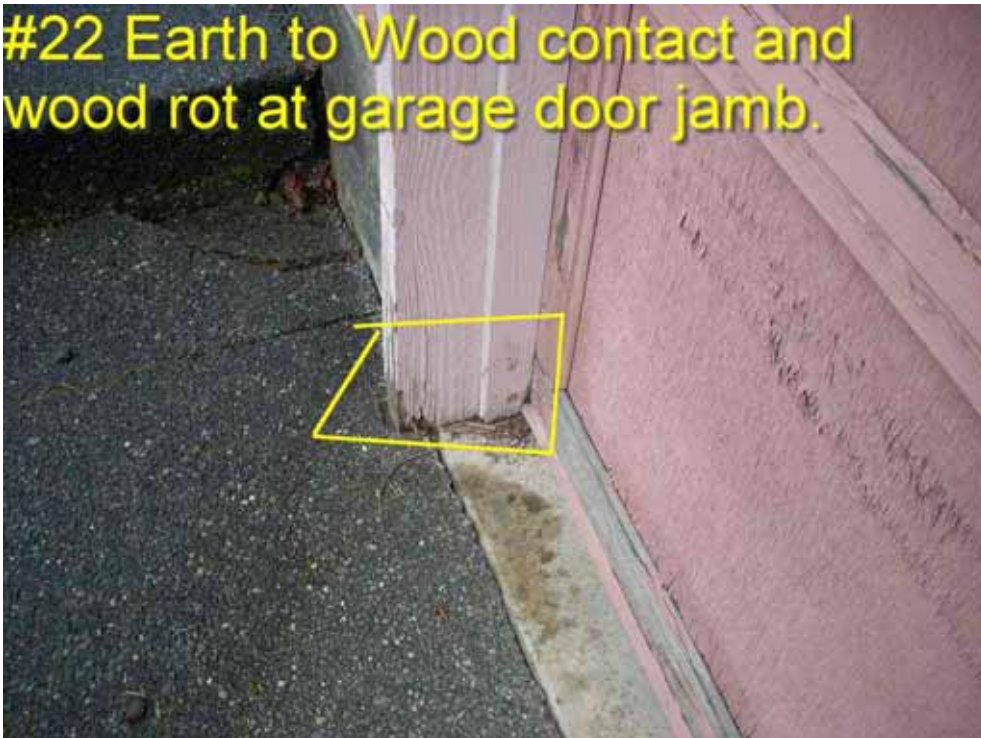
#22 Earth to Wood contact and wood rot at garage door jamb.

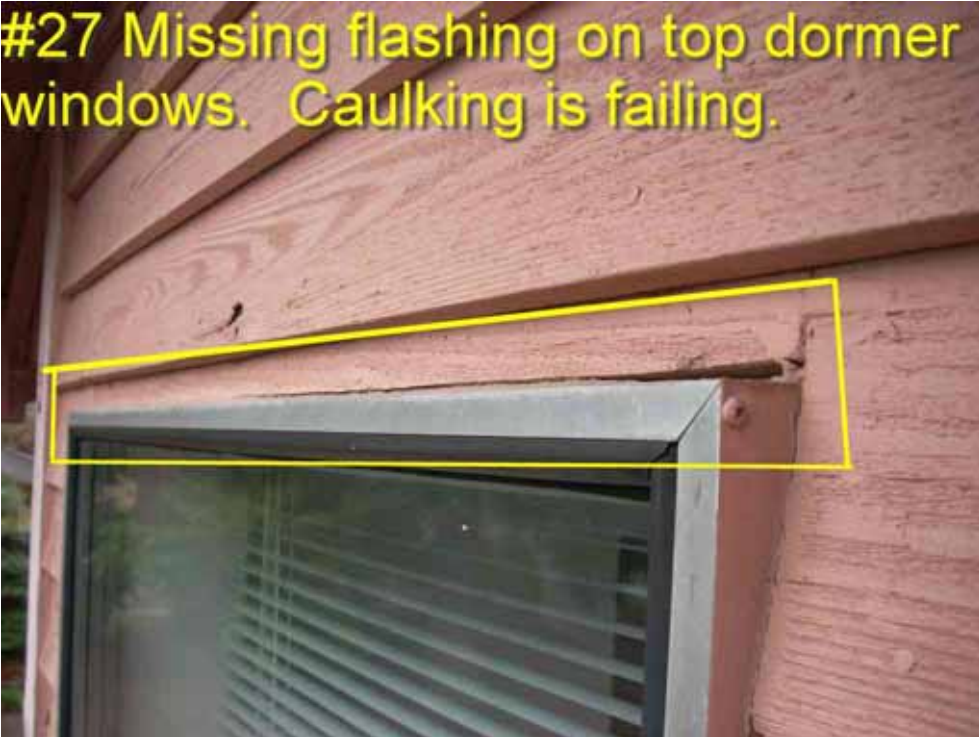
- j. The dormer windows above the garage do not have flashing on the top side for weather protection, and the caulking is failing. There could be hidden water damage here. (See Photo#27, 32)
- k. Exhaust vents in attic do not have a positive connection to the outside. This is a conducive pest issue and possible factor contributing to the light mold in the attic. (See Photo#34, 35)
- l. Contact Gary Broker for carpentry repairs, at 253-232-6406

#27 Missing flashing on top dormer windows. Caulking is failing.

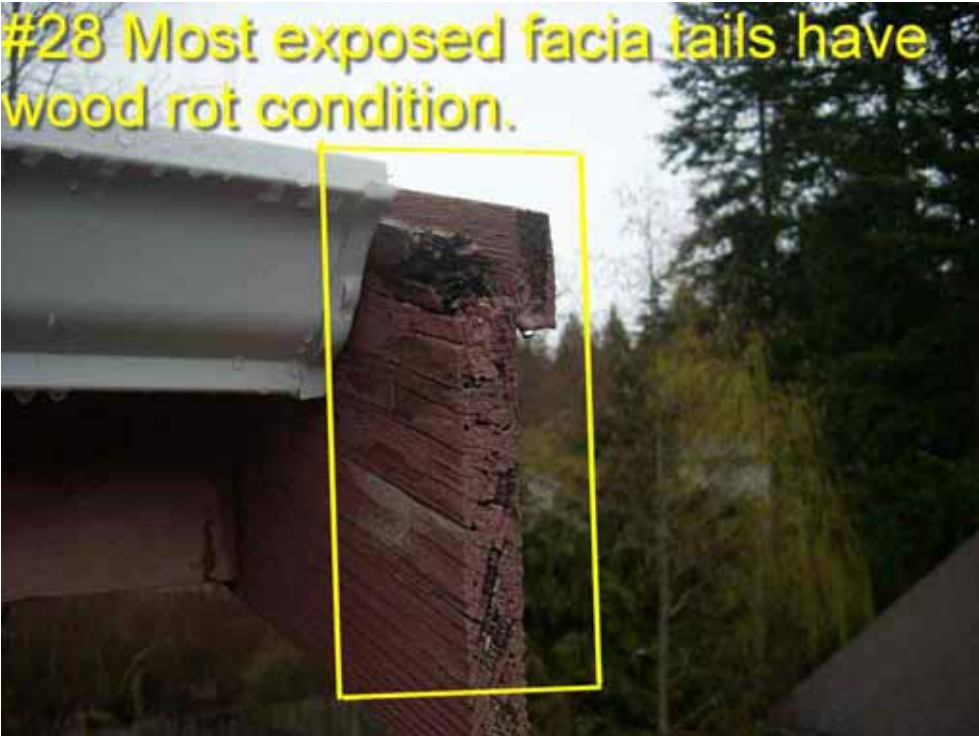
#28 Most exposed fascia tails have wood rot condition.

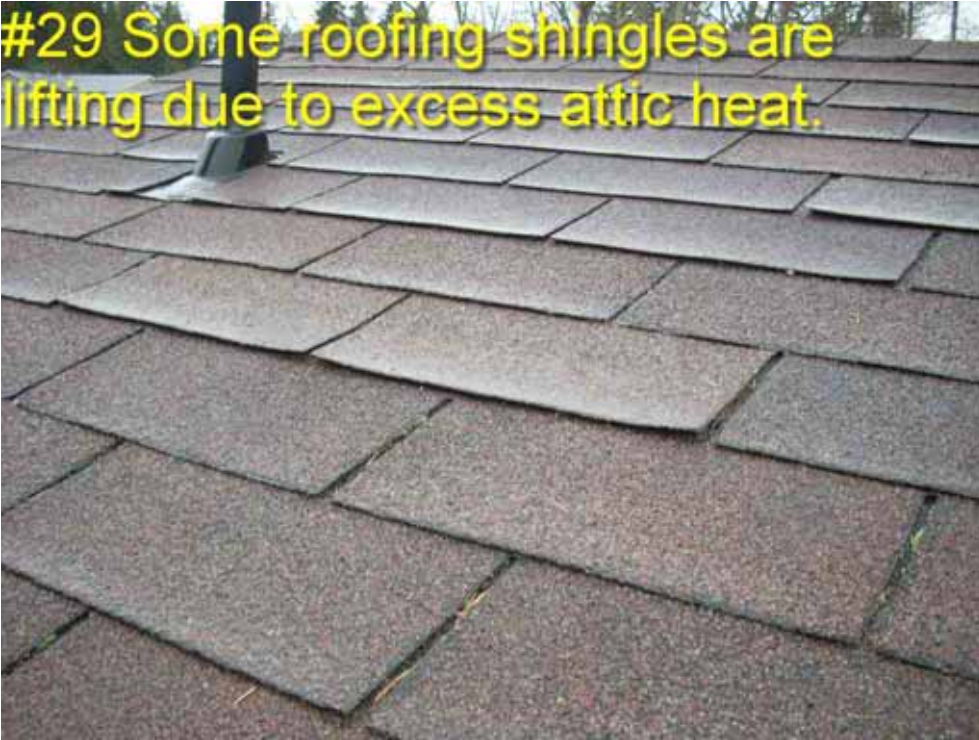
- a. The threshold and strike plate for the side garage door need repaired or replacement. (See Photo#12, 51)
- b. The siding is in need painting this year. (See Photo#25)
- c. The roofing has shingles which are curling up, and there are darkened areas, especially near the ridge vents, which indicate excessive attic heat. The roof needs more top side vents and the upper attic needs improved air flow in the attic on the south side. Improved air flow will also resist future mold issues in the attic. The roofing material appears to have about 5 years (+/- 2years) of life left. (See Photo#29, 30, 37)

#29 Some roofing shingles are lifting due to excess attic heat.

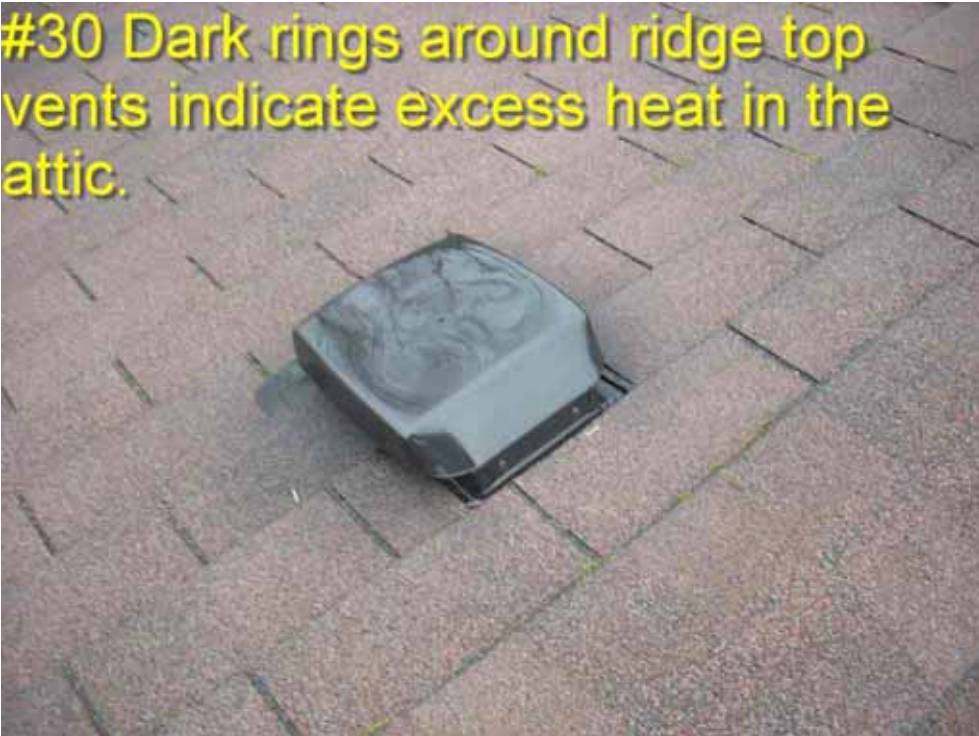
#30 Dark rings around ridge top vents indicate excess heat in the attic.

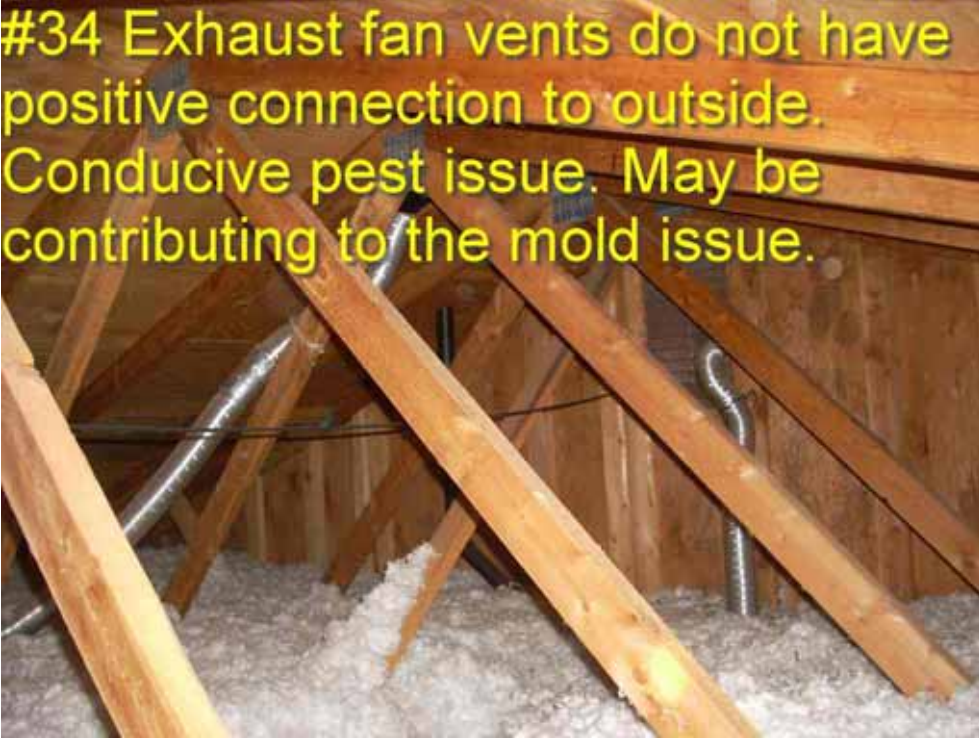
#34 Exhaust fan vents do not have positive connection to outside. Conducive pest issue. May be contributing to the mold issue.

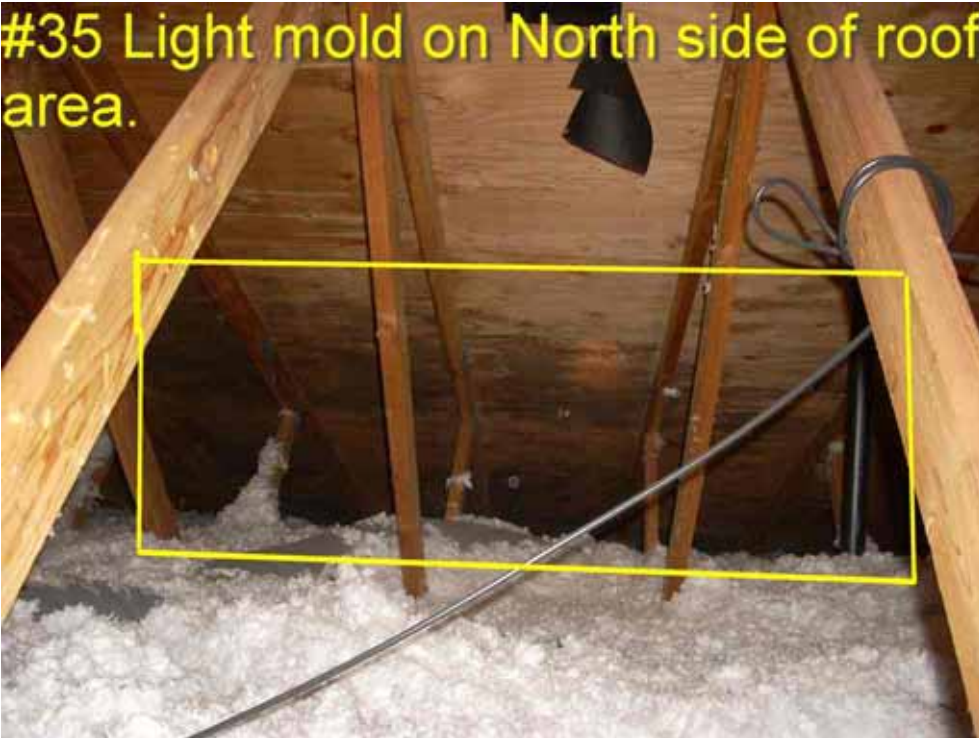
#35 Light mold on North side of roof area.

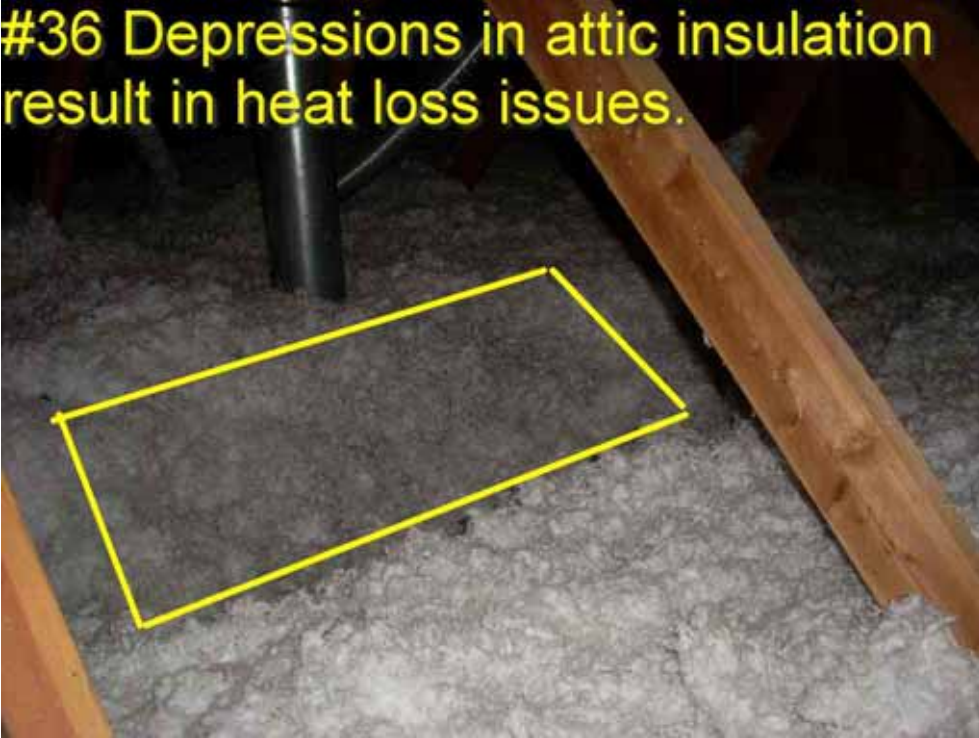
- 4. Vinyl flooring in the main bath room needs to be glued down. (See Photo#38)
- 5. Depressions in the attic insulation result in heat loss. Have the insulation raked and restored to level and uniform conditions. (See Photo#36)

#36 Depressions in attic insulation result in heat loss issues.

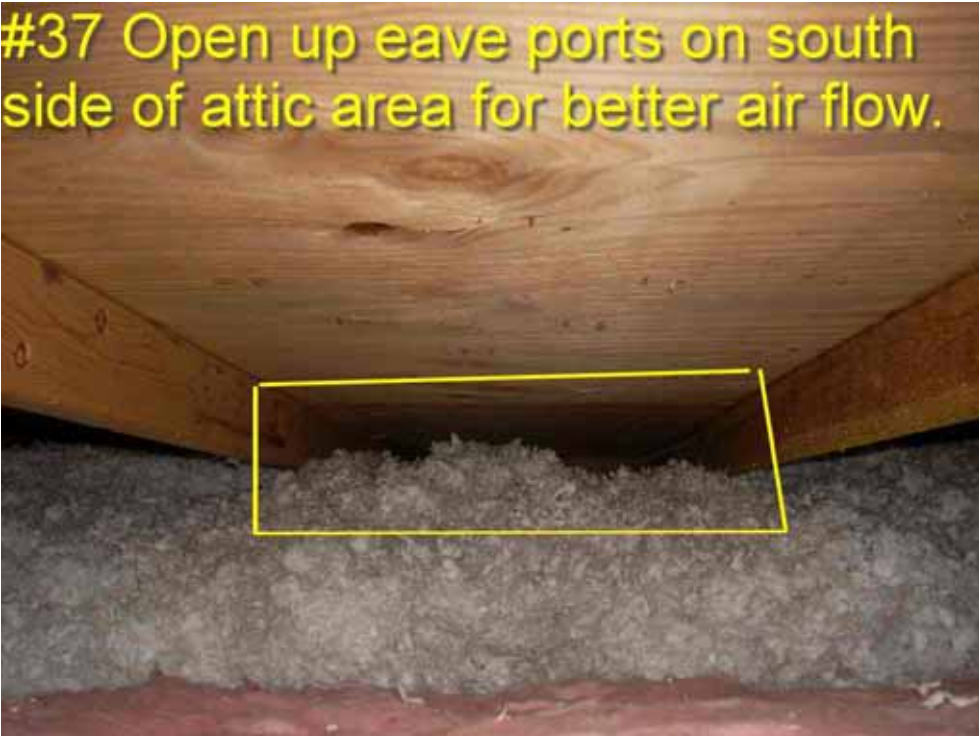
#37 Open up eave ports on south side of attic area for better air flow.

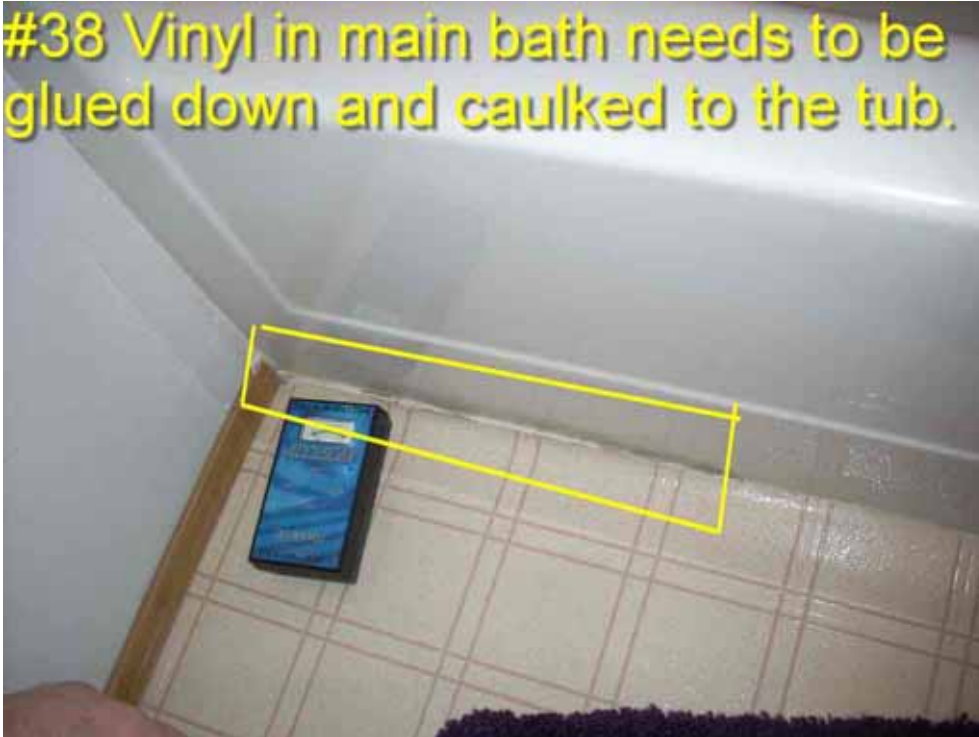
#38 Vinyl in main bath needs to be glued down and caulked to the tub.

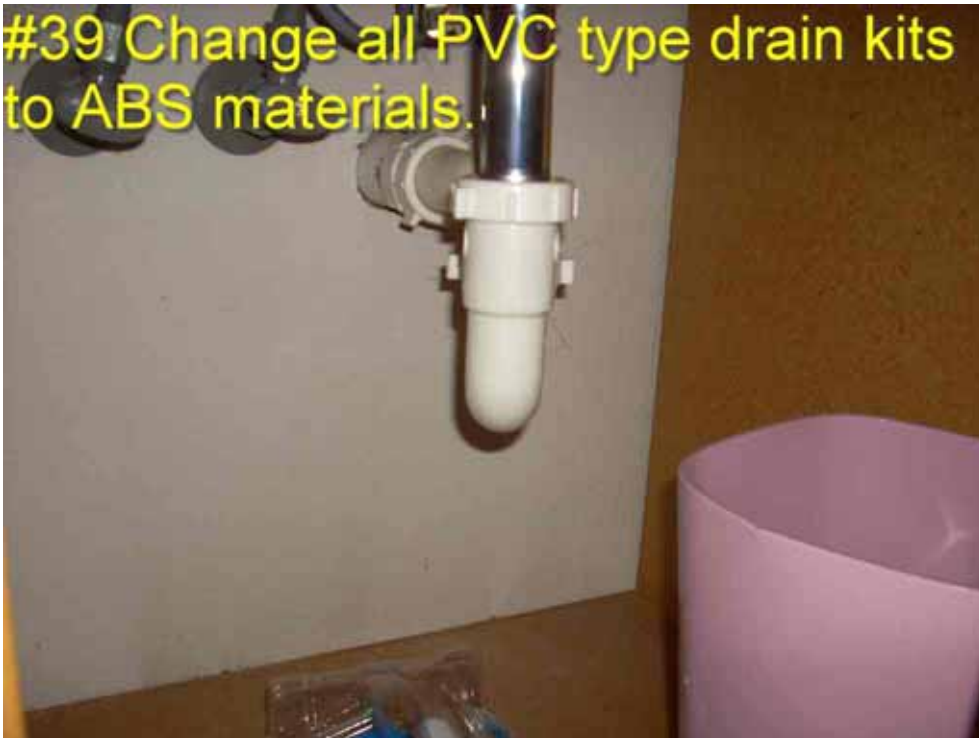
#39 Change all PVC type drain kits to ABS materials.

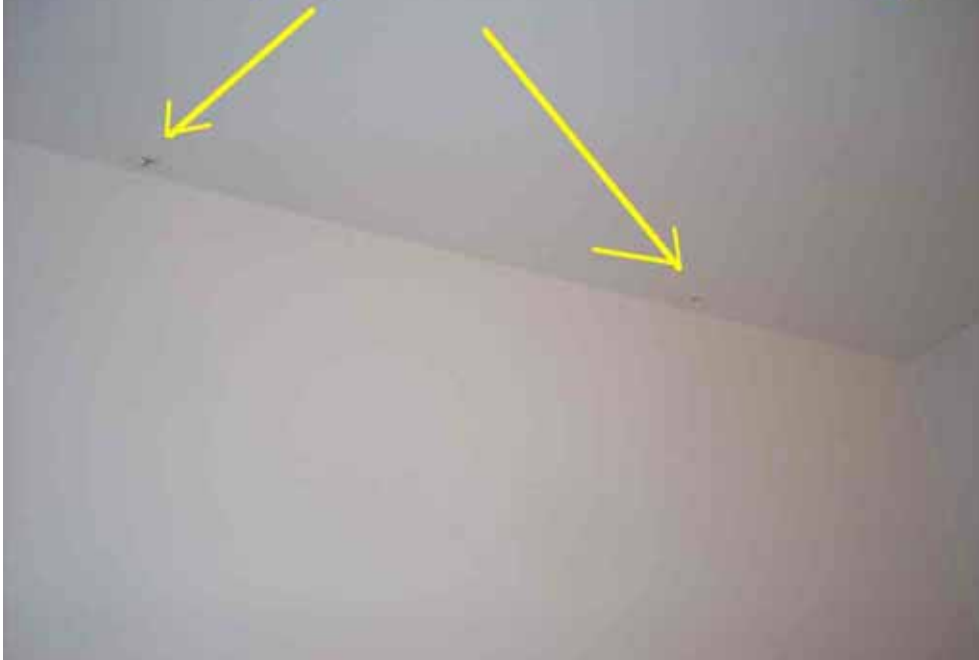
- 6. There are some nail pops in the main bath room which could be touched up with some drywall mud and texture, and there is small dry wall crack in the kitchen too. (See Photo#40, 44)

#40 Nail pops in bathroom ceiling.

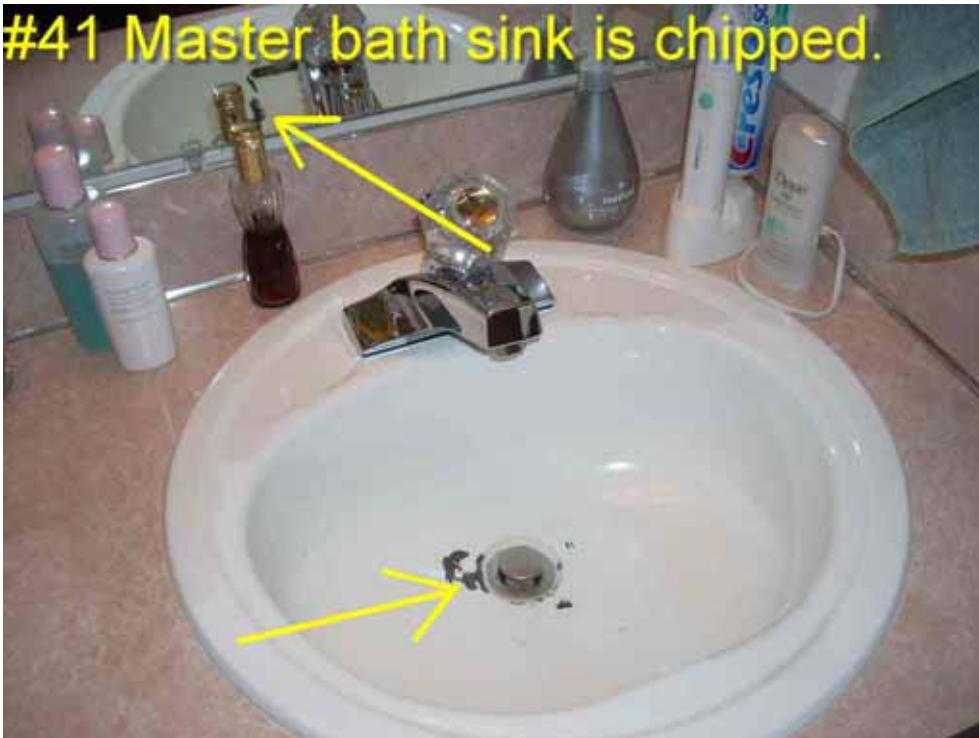
- 7. Replace the sink in the master bathroom. There are several chips in the enamel. (See Photo#41)
- 8. The carpet needs to be re-stretched through out the home. (See Photo#43)

#41 Master bath sink is chipped.

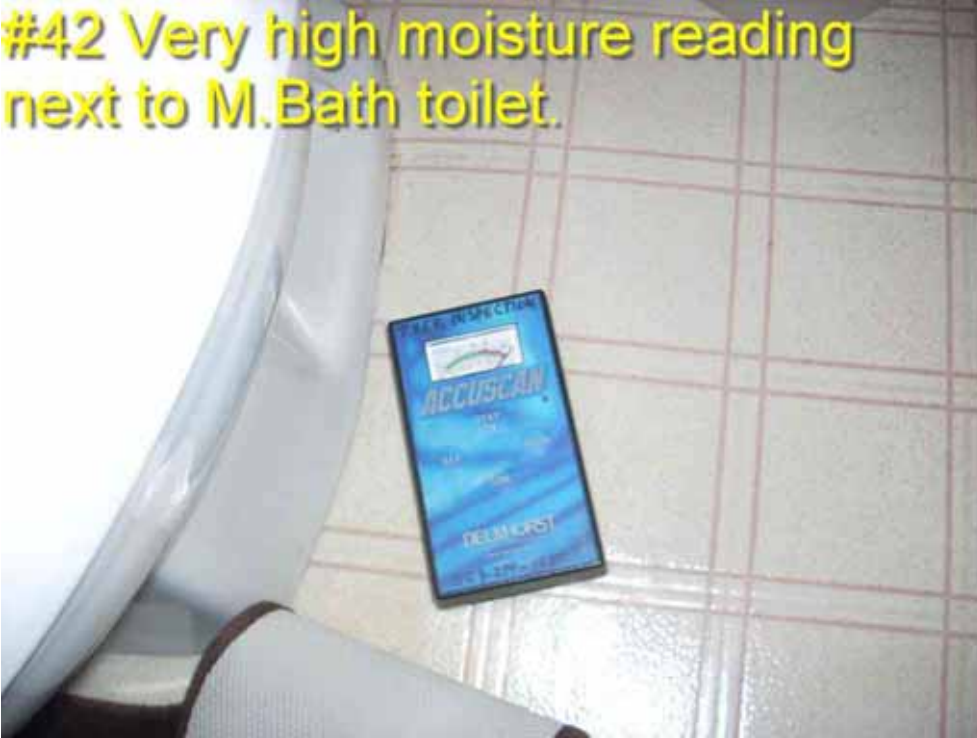
- b. The master bathroom toilet appears to be leaking at the wax ring. The moisture level here is 40%. The sub flooring is swelling significantly. This floor will need to be repaired. Use plywood (A/C or C/CPTS)for the new sub flooring. (See Photo#42)

#42 Very high moisture reading next to M. Bath toilet.

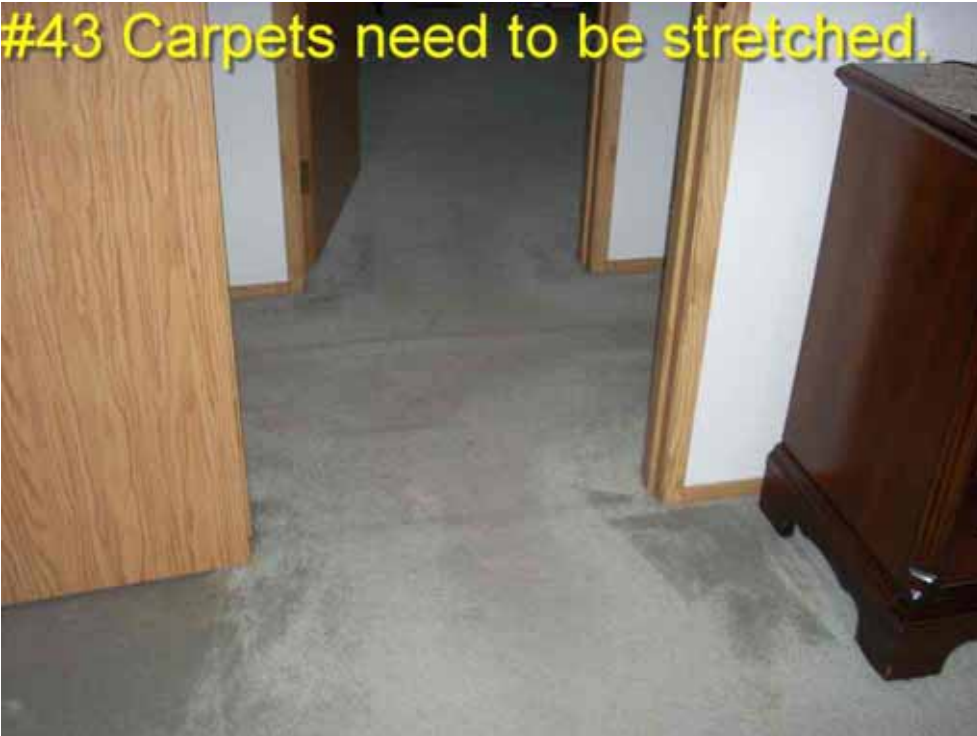
#43 Carpets need to be stretched.

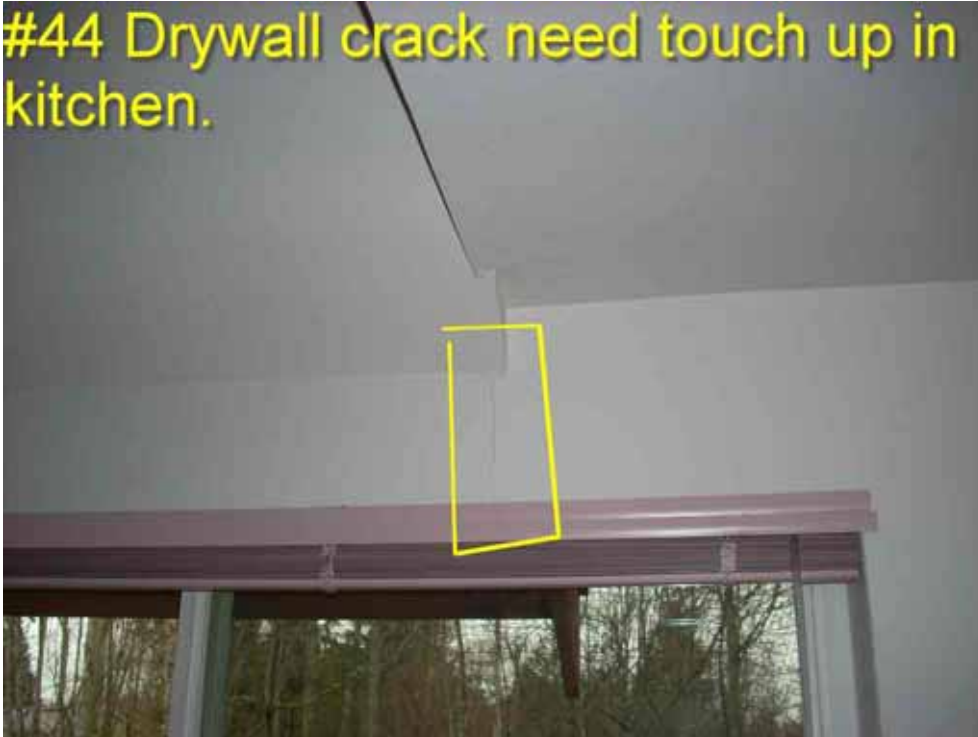
#44 Drywall crack need touch up in kitchen.

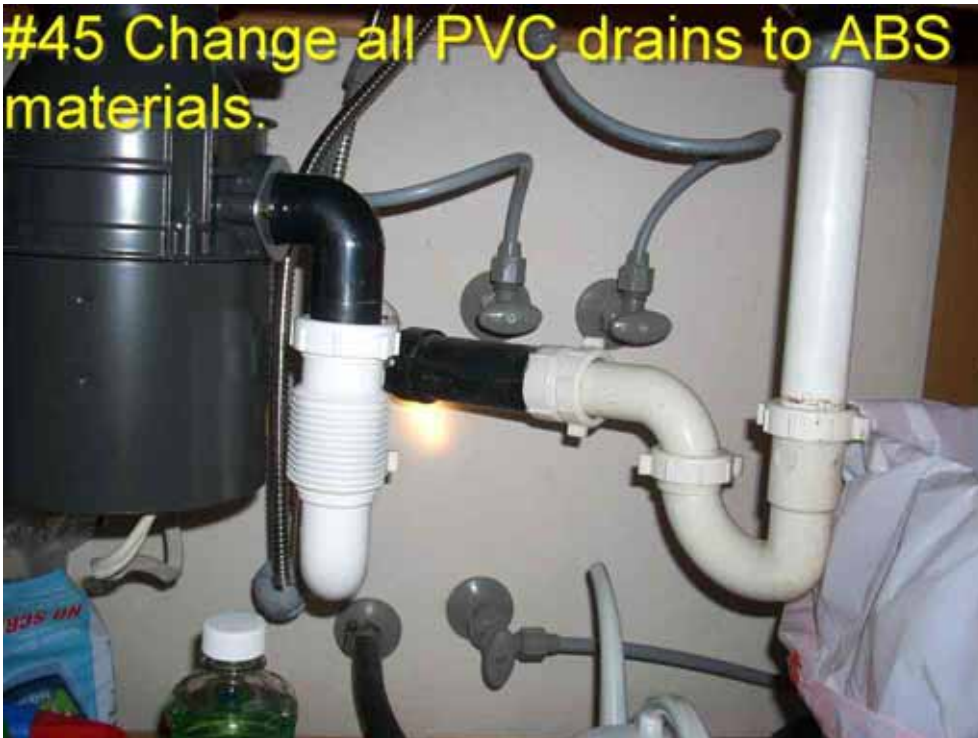
4. Consider installing an Air-to-Air exchanger in the home to improve indoor air quality.
5. Consider changing the PVC drain pipes under the sinks to ABS, since PVC is prone to loosen up and leak. (See Photo#39, 45)

#45 Change all PVC drains to ABS materials.

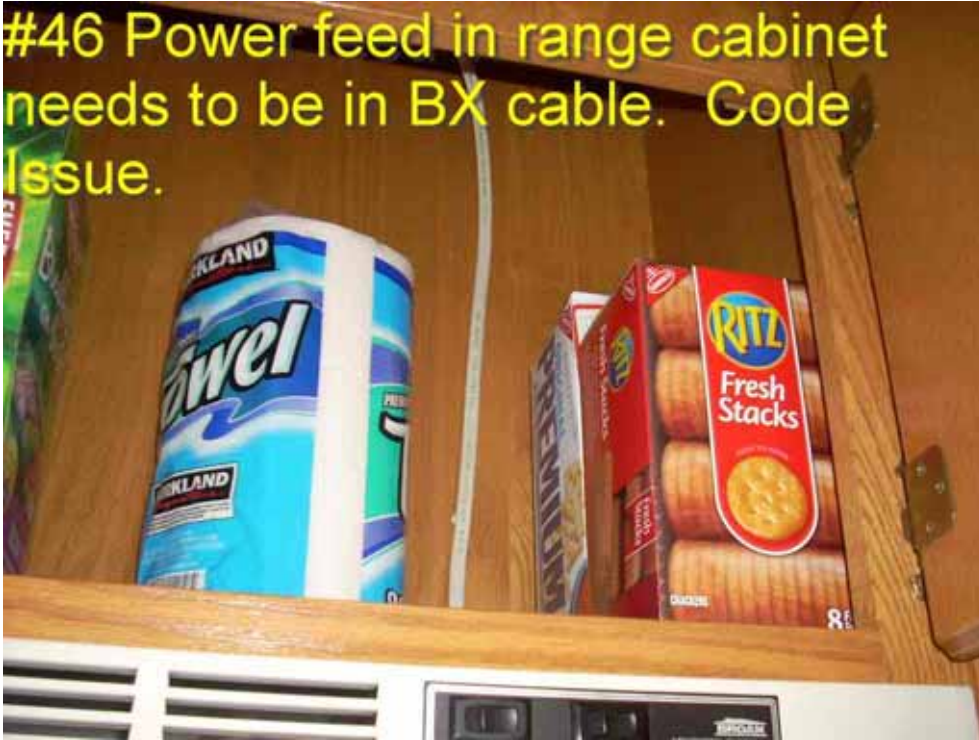
#46 Power feed in range cabinet needs to be in BX cable. Code Issue.

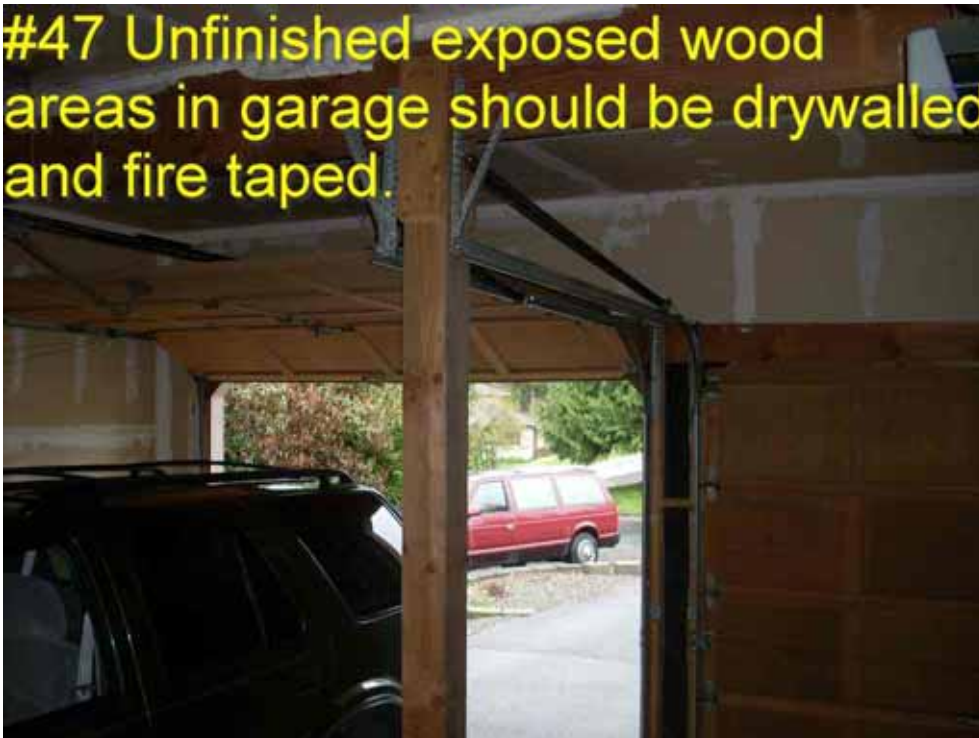
#47 Unfinished exposed wood areas in garage should be drywalled and fire taped.

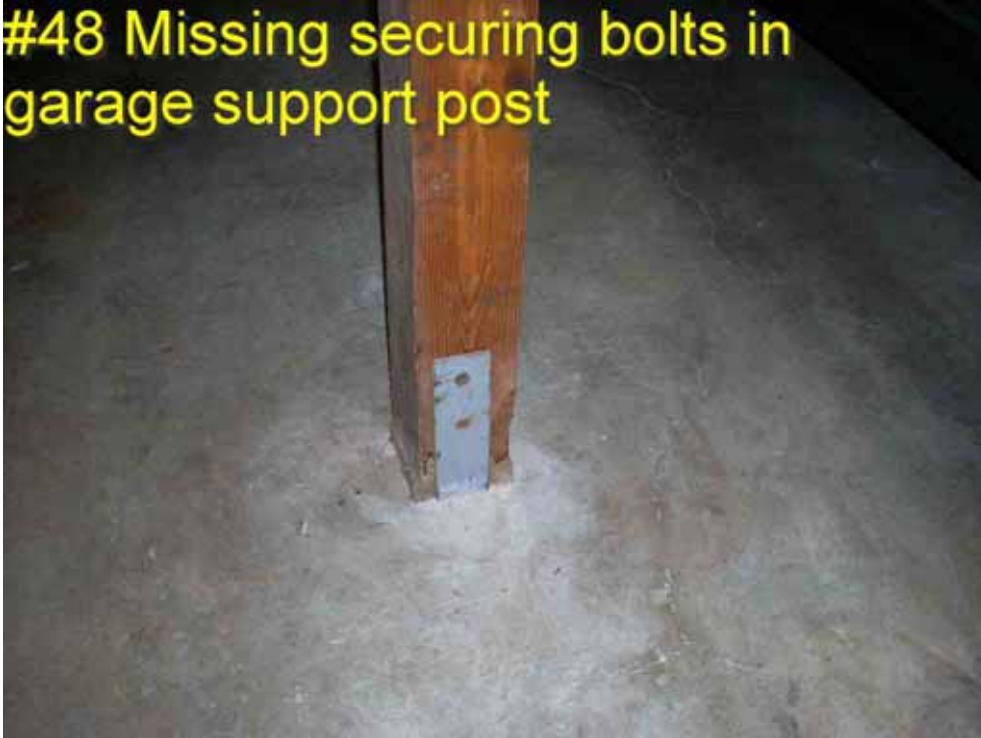
#48 Missing securing bolts in garage support post

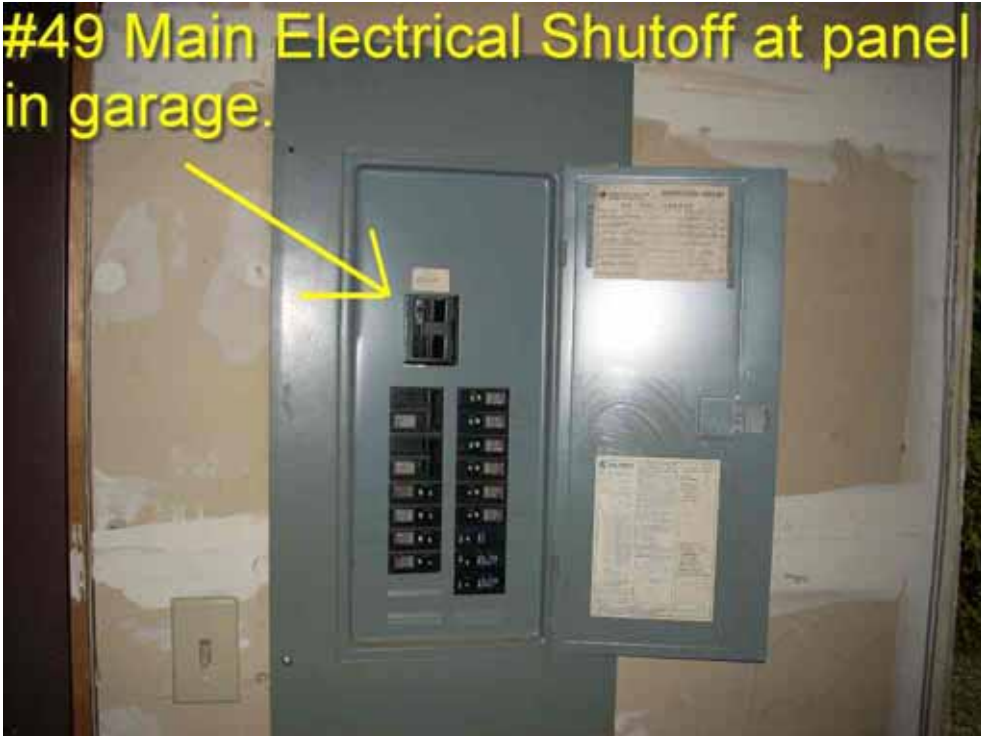
#49 Main Electrical Shutoff at panel in garage.
