## Structural Home Inspection Report

TO: Jane Doe  
19402 77<sup>th</sup> St E  
Bonney Lake WA 98391

INSPECTION DATE: February 26, 2010

**Address of Residence Inspected:** 19402 77<sup>th</sup> St E, Bonney Lake WA 98391

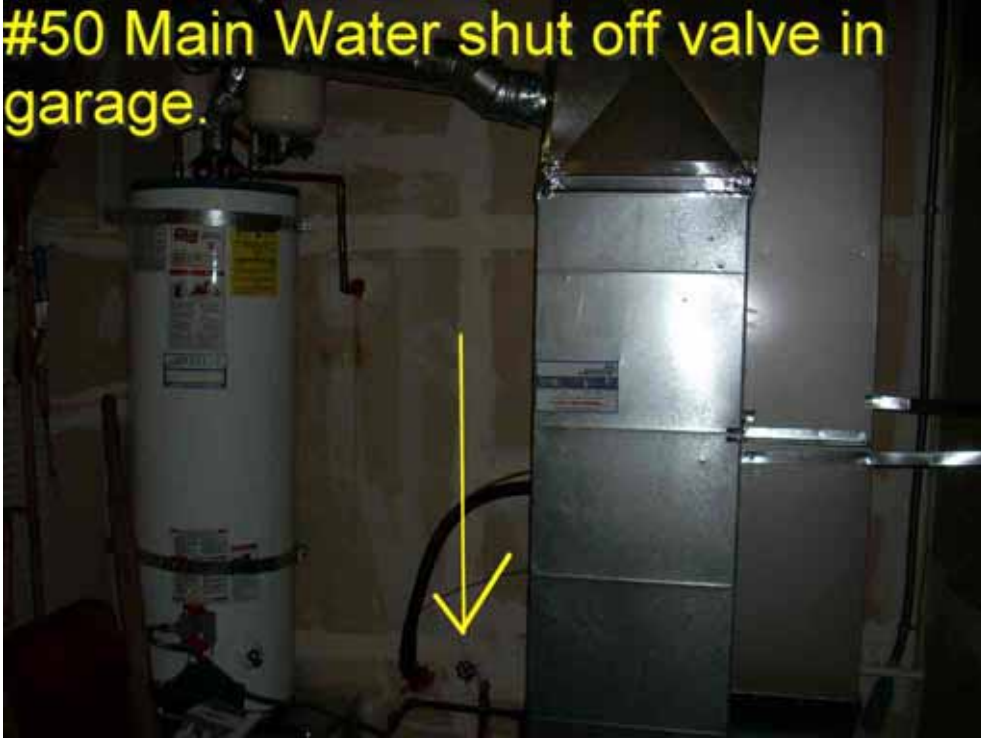
#50 Main Water shut off valve in garage.

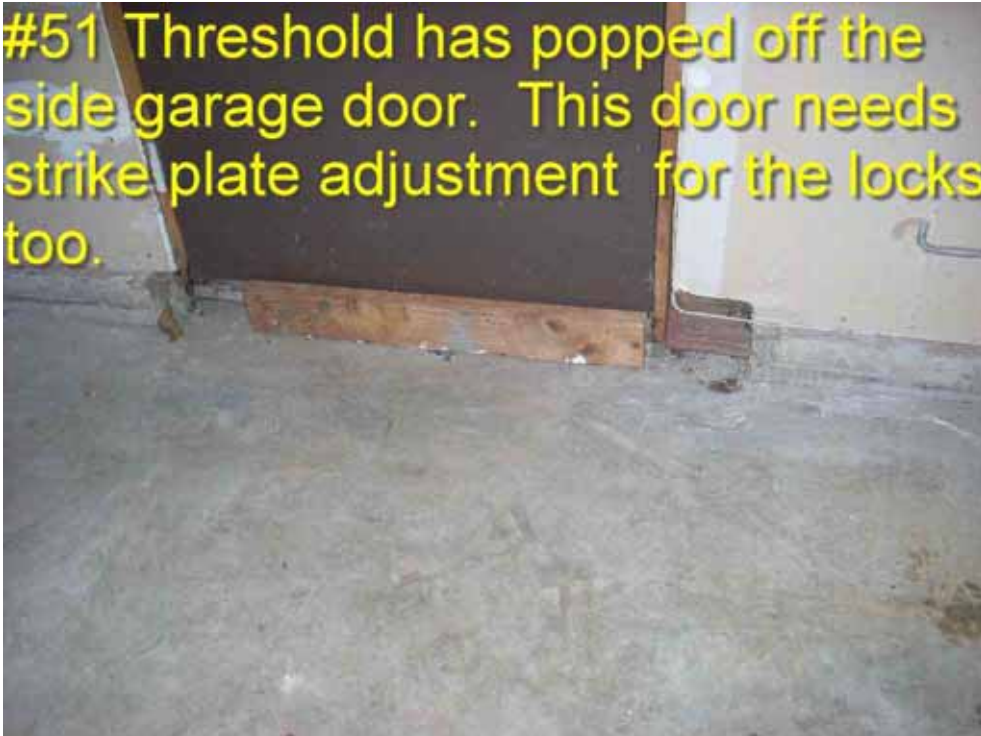
- a. The threshold and strike plate for the side garage door need repaired or replacement. (See Photo#12, 51)
- b. The siding is in need painting this year. (See Photo#25)
- c. The roofing has shingles which are curling up, and there are darkened areas, especially near the ridge vents, which indicate excessive attic heat. The roof needs more top side vents and the upper attic needs improved air flow in the attic on the south side. Improved air flow will also resist future mold issues in the attic. The roofing material appears to have about 5 years (+/- 2years) of life left. (See Photo#29, 30, 37)

#51 Threshold has popped off the side garage door. This door needs strike plate adjustment for the locks too.

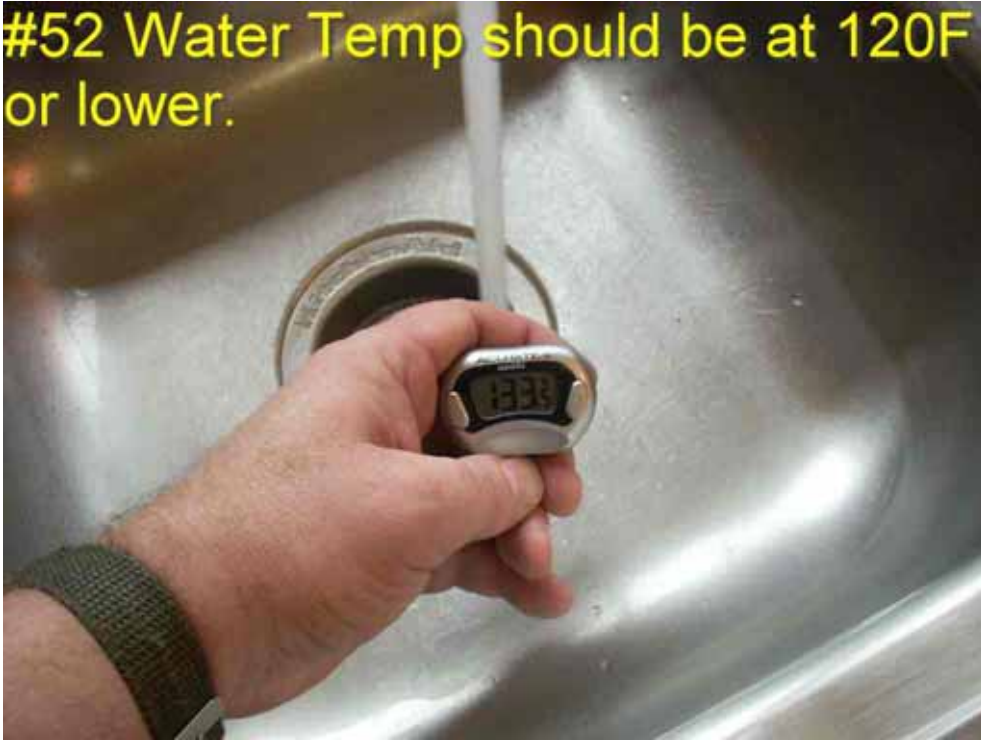
- f. Make sure the hot water temperature is 120F or below. (See Photo#52)
- g. Both garage door opener motors need to have the back pressure sensor adjusted properly. (See Photo#53)

#52 Water Temp should be at 120F or lower.

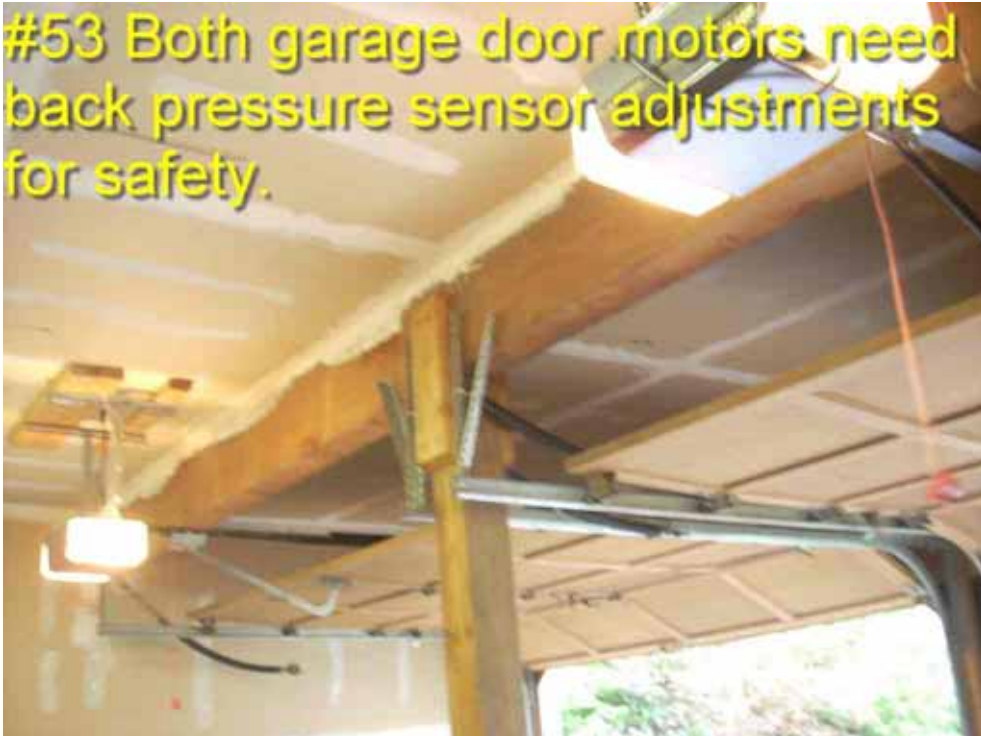
#53 Both garage door motors need back pressure sensor adjustments for safety.

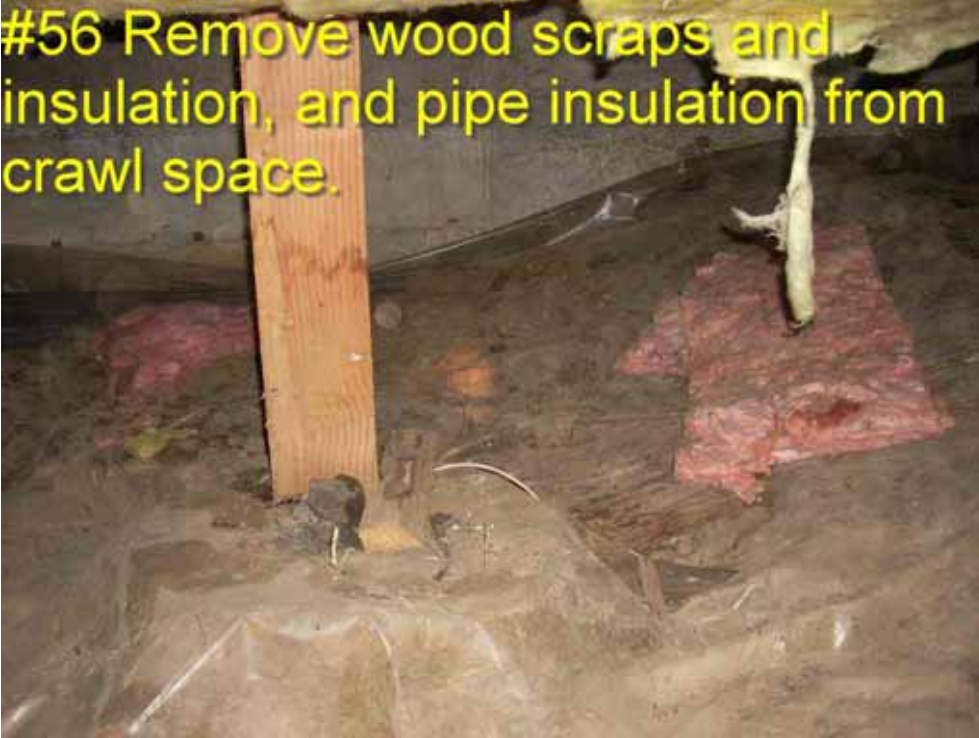
- h. Remove the wood debris and construction debris from the crawl space area. (See Photo#55, 56, 57)
- i. The decorative cedar tree stump is a pest magnet in the back yard. I would recommend removal or annual treatment by a Pest Control Operator-PCO. (See Photo#15)

#56 Remove wood scraps and insulation, and pipe insulation from crawl space.

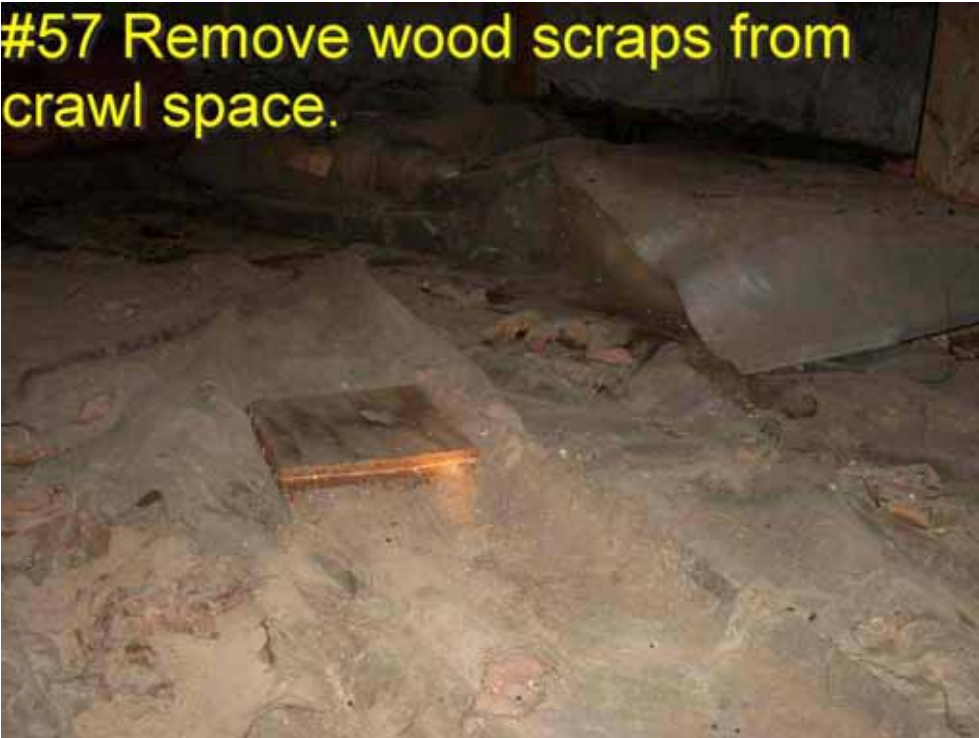
#57 Remove wood scraps from crawl space.

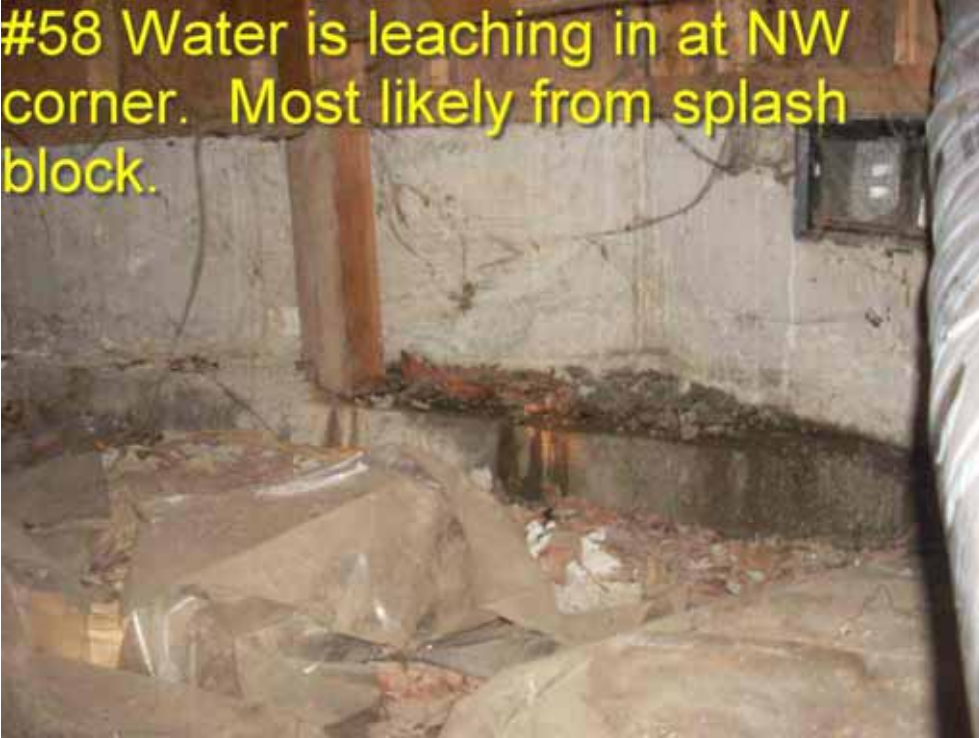
- 2. The displaced splash block on the NW corner appears to contributing to the water leaching over the footing inc the crawl space (See Photo#20, 58)
- 3. There is some light moss on the roof. Have this removed. (See Photo#26)

#58 Water is leaching in at NW corner. Most likely from splash block.
