# Trek Inspection Services, Inc.

## Structural Home Inspection Report

INSPECTION DATE: Jan 3, 2005

**Address of Residence Inspected:** Somewhere in University Place, WA 98466

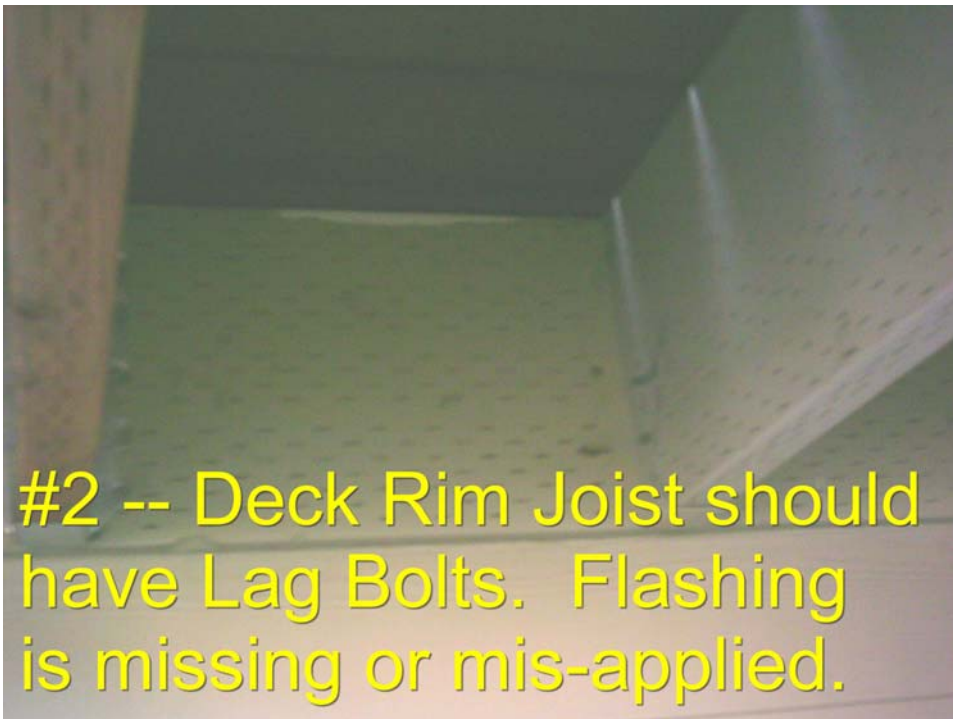
1. Drainage outside of South East Corner of Garage. (See Photo #4)
2. Front Porch: rim joist not lag bolted to wall. (See Photo #2)
3. Front Porch: Did not see flashing between wall and first run of decking.
4. Crawl Space: vapor barrier under laundry room has slid off. (See Photo #3)
5. Caulk underside of bay window projection to keep out bugs. (See Photo #5)
6. Protection Barrier is missing in Garage to prevent collision with gas furnace and hot water tank. (Code issue) This is often a pipe stand or curb fastened to the garage floor in front of the equipment. (See Photo #6)

**#2 -- Deck Rim Joist should have Lag Bolts. Flashing is missing or mis-applied.**

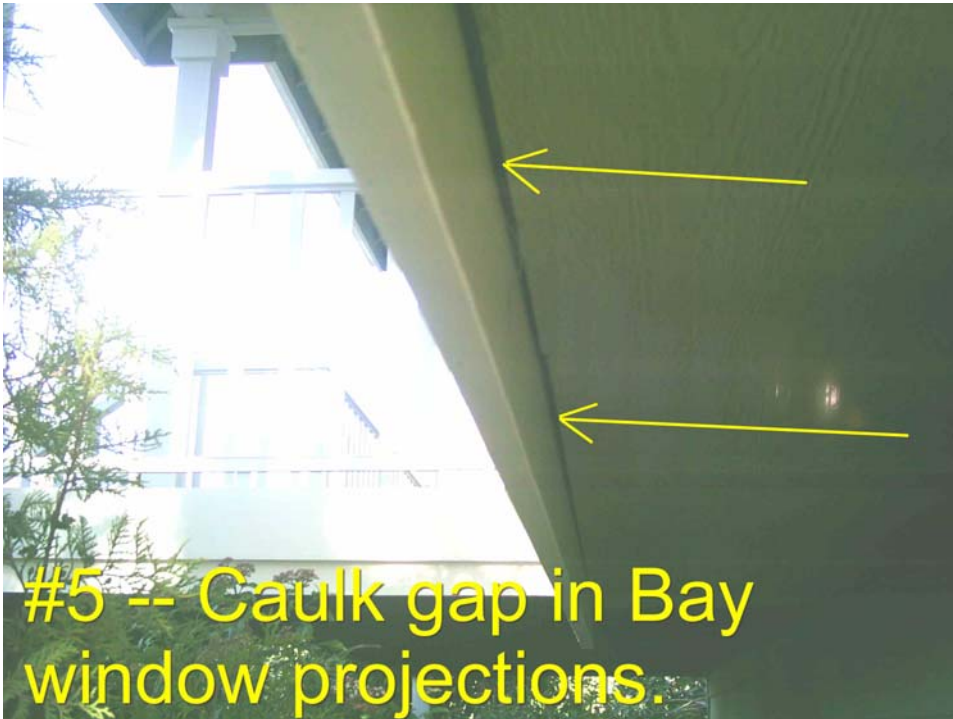
#5 -- Caulk gap in Bay window projections.

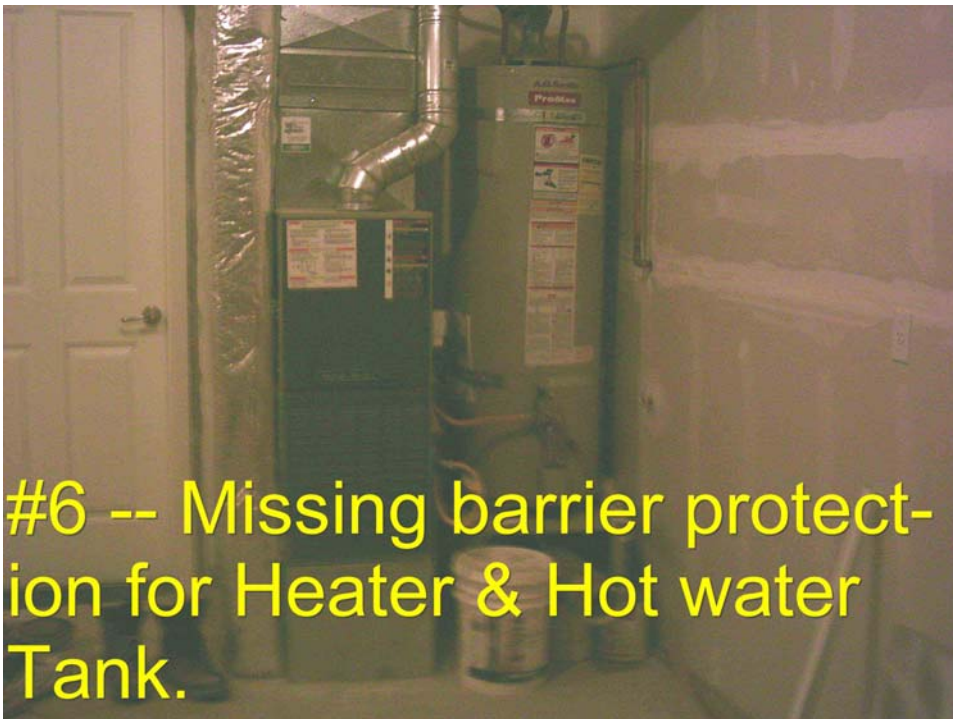
#6 -- Missing barrier protection for Heater & Hot water Tank.
